MERRIMAN DAM

PHASE I INSPECTION REPORT

NATIONAL DAM SAFETY PROGRAM.

Merriman Dam (NY 00121). Hudson River Valley, Roundout Creek, Ulster County, New York. Phase I Inspection Report.

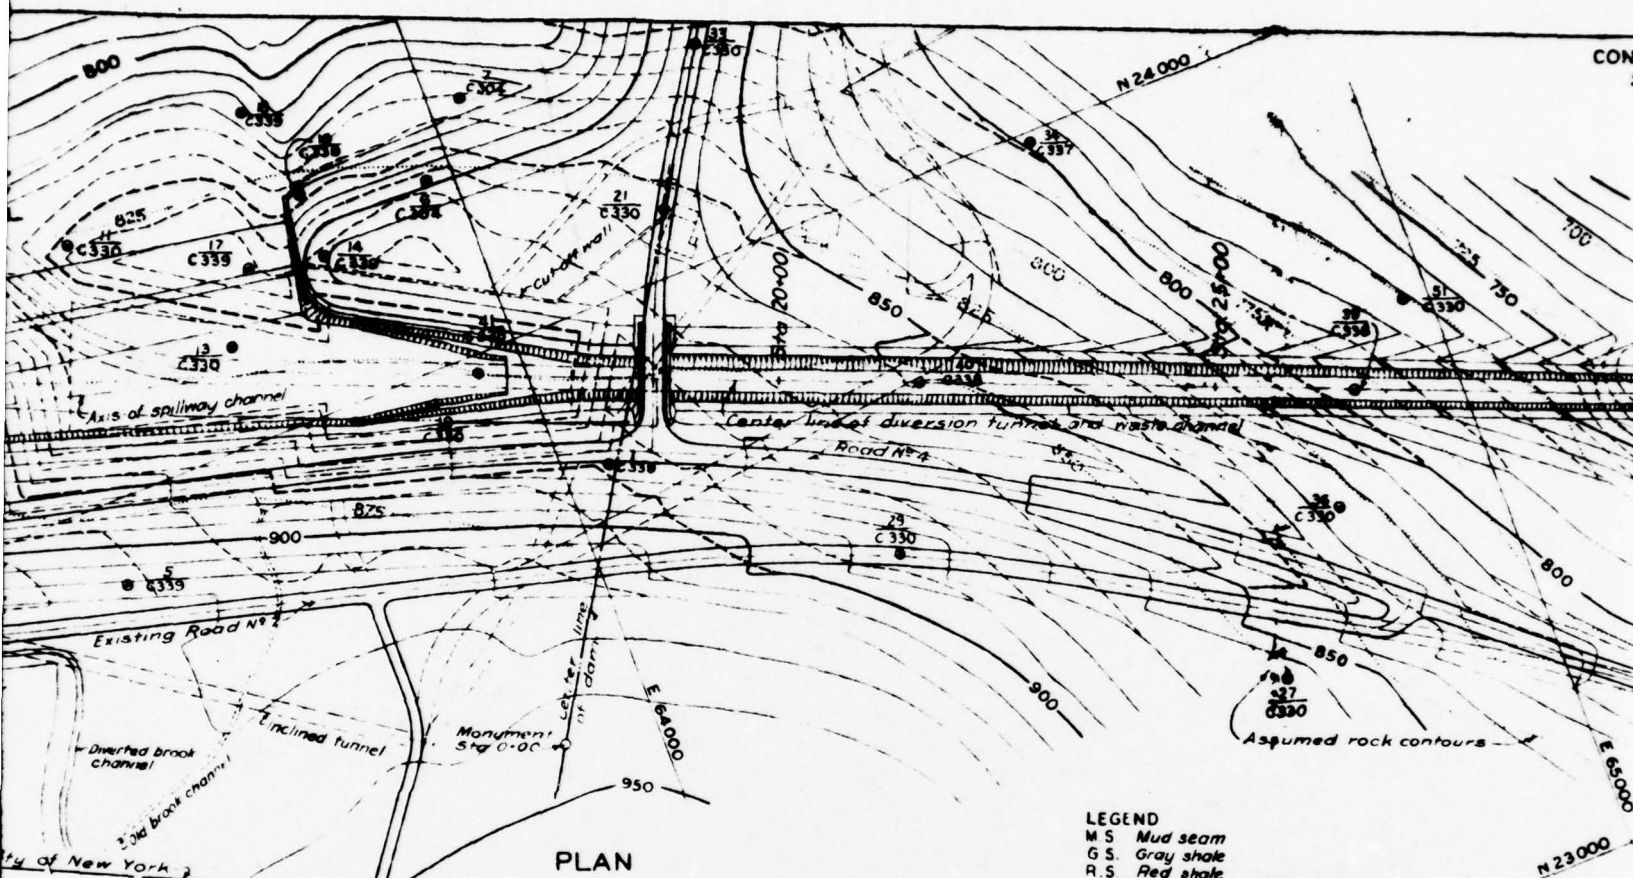
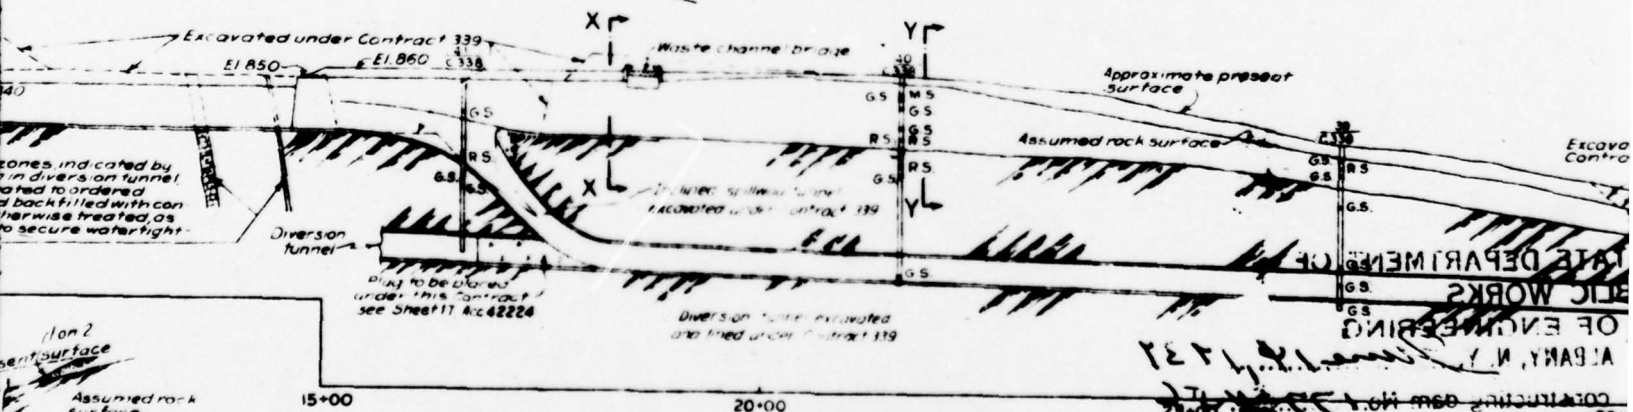
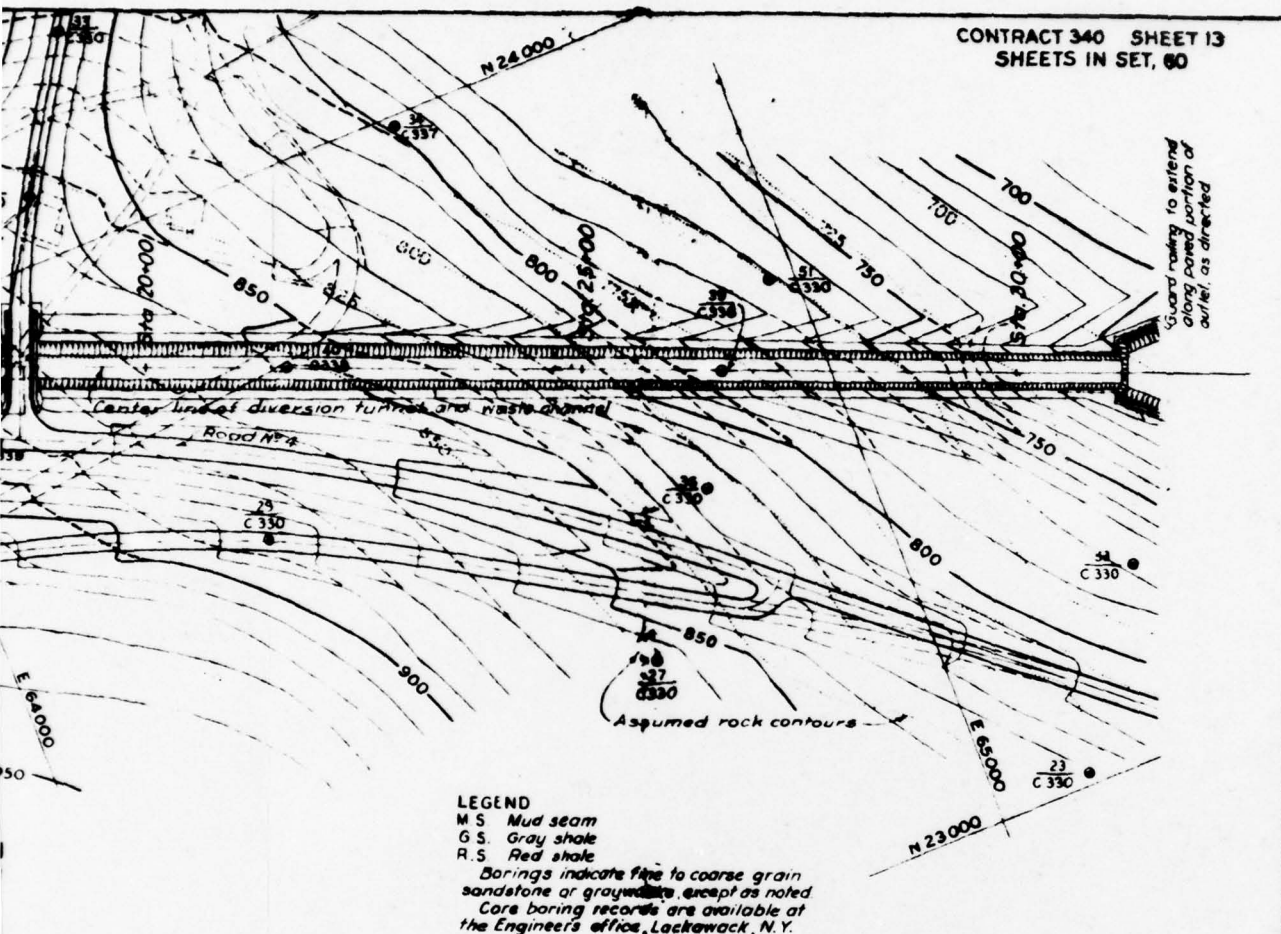
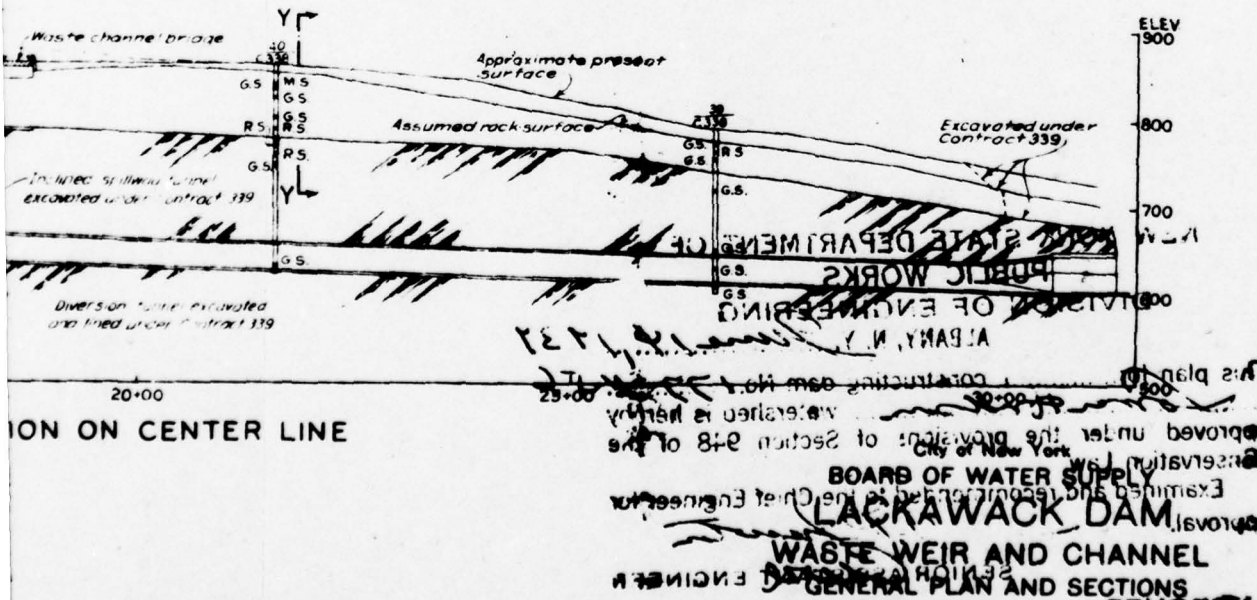
FIGURE 6

2. Overflow Spillway and Channel - The overflow spillway and channel are constructed of large cut stones. The spillway (elevation 840) is 600 feet long. Water passes over the spillway onto a series of rock berms, then into a wide stone lined channel (see Photograph #A-11). This channel leads into a tunnel which discharges flow into Rondout Creek downstream of the dam. Flow in excess of the capacity of the tunnel is discharged by means of concrete lined channel (see Figure 6) located above the tunnel. This channel also discharges flow into Rondout Creek.

Minor seepage through the eastern end of the spillway was observed but should not affect the structural stability of the spillway section.

VISUAL EXAMINATION OF	OBSERVATIONS	REMARKS OR RECOMMENDATIONS
CUT STONE WEIR	Generally in excellent condition, minor seepage through the spillway approximately 6' below the crest near the eastern end.	Monitor seepage, insure that it does not increase. If increase occurs, make structural repairs.
APPROACH CHANNEL	Excellent condition.	None.
DISCHARGE CHANNEL A-8	Excellent condition. Well-maintained, free of debris, adequate to pass probable maximum flow.	None.
BRIDGE AND PIERS	None.	None.

2. Seepage through the eastern section of the spillway should be monitored; if the flow increases, remedial measures should be taken. A partial drawdown of the reservoir may be necessary to make the necessary repairs at the source of the flow.
